09/20/81 World Airways, Inc.

Official Accident Report Index Page

Report Number	NTSB-AAR-82-1
Access Number	PB82-910401
Report Title	Airways Inc., Flight 32, McDonnell Douglas DC-10-30CF, N112WA, Over North Atlantic Ocean, September 20, 1981.
Report Date	January 12, 1982
Organization Name	National Transportation Safety Board Bureau of Accident Investigation Washington, D.C. 20594
WUN	3378A
Sponsor Name	NATIONAL TRANSPORTATION SAFETY BOARD Washington, D. C. 20594
Report Type	Aviation Accident Report
Sup Notes	The subject report was distributed to NTSB mailing lists: 1A, 8A and 8B.
Distribution Status	This document is available to the public through the National Technical Information Service-Springfield, Virginia 22161 (Always refer to number listed-in item 2)
Report Class	UNCLASSIFIED
Pg Class	UNCLASSIFIED
Pages	54
Keywords	DC-10, galley lift system, design deficiencies, operations procedures.
Abstract	About 0245 G.m.t. on September 20, 1981, a flight attendant on board World Airways Flight 32, a DC-10-30CF, was fatally injured as a result of being trapped between a service cart in the galley personnel lift and the ceiling of the lower galley as the lift raised. There were 331 reve

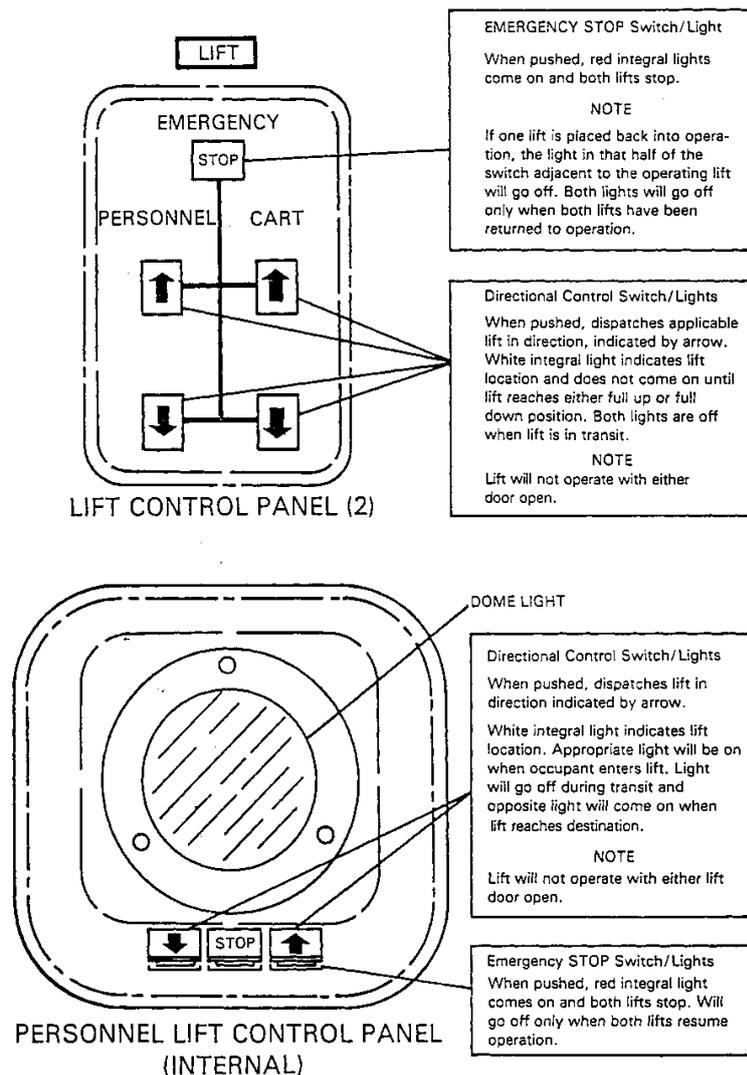
Figure 2.--Personnel and cart lifts.

The lower galley personnel lift door frame was deformed and battered in the area where the electrical interlock switches are mounted(see [figure 2](#)). The uppermost electrical interlock switch on the lower galley personnel lift door, S1-450(see [figure 1](#)), was found with the switch roller assembly twisted and the roller striker arm jammed in the depressed (switch closed) position. The damage to the lower galley lift door frames was the result of repeated bumping by food and liquor carts.
